**title:** ANACAPA ISLAND SPLIT PIPE INSTALLATION  
INSPECTION AND REPAIR 1978-79

**author:** W. R. Tausig and R. L. Brackett

**date:** February 1980

## CIVIL ENGINEERING LABORATORY

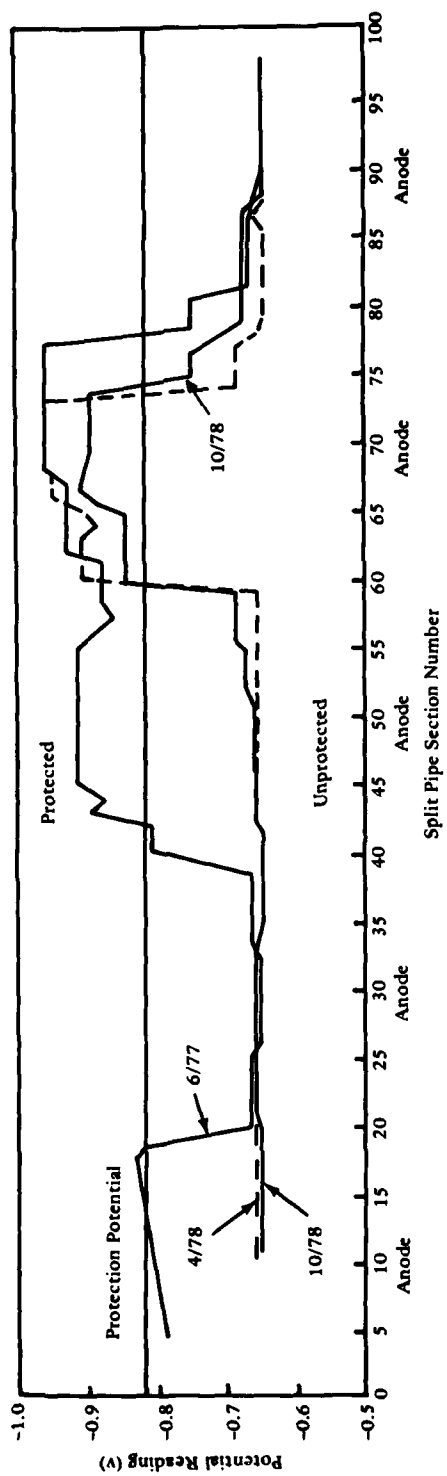
Standard galvanic potential readings were taken with an underwater voltmeter on each pipe section. Results of these readings, together with the readings taken on the two previous inspections, are presented in Figure 1. These results show that the cathodic protection system continued to deteriorate. This deterioration is primarily caused by the increasing number of failed jumper cables that were broken or missing between pipe sections 10 through 27, 29 and 30, 34, through 37, 39 through 41, 44 and 45, 59 and 60, 85 through 87, and 96 and 97. Only pipe sections 60 through 74 were cathodically protected by the anode located at pipe section 70. All of the other remaining pipe sections were unprotected.

Figure 1. Cathodic protection potential.

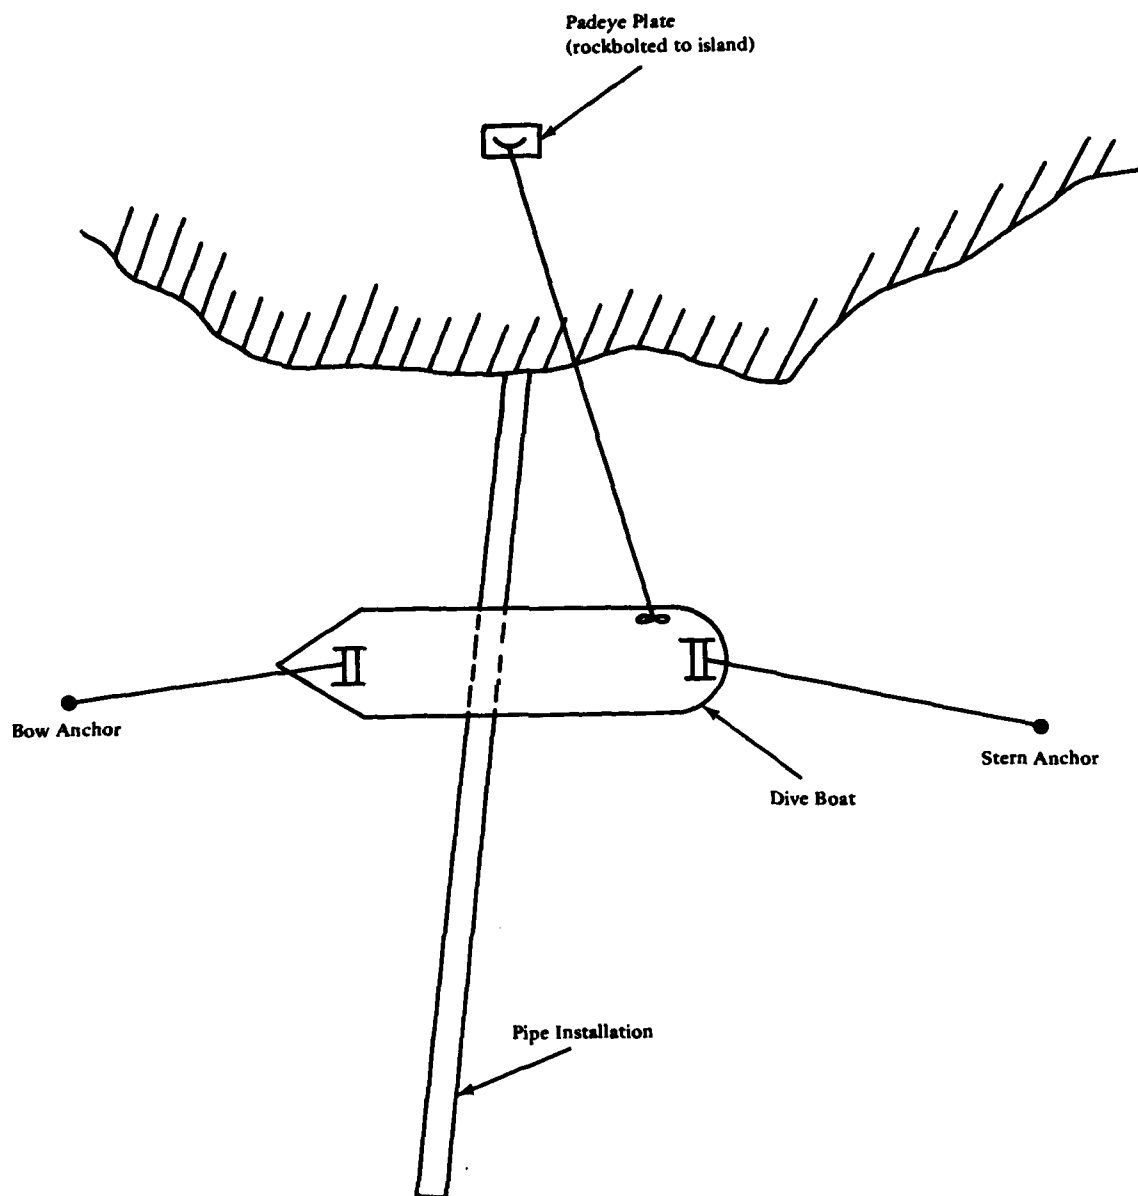
Figure 2. Three-point moor.

On March 5, 1979, the split pipe installation was surveyed and prepared for the repair work. The dive/work boat was first placed into a 3-point moor by dropping the bow and stern anchor and tying off to the island. Figure 2 shows the 3-point moor. In this manner, the dive boat could be maneuvered close to the island directly over the pipe installation and be used as the work platform for the hydraulic tools. A padeye plate was then rockbolted in place to the island. This plate was to be used as a future anchor point for the dive boat, and also for holding a pulley block for pulling split pipe on shore. Four holes were drilled into the rock with the hydraulic rockdrill. Rockbolts were then installed to hold the padeye plate in place. Figure 3 shows the installation of the padeye plate.
